CALIFORNIA REGIONAL WATER QUALITY CONTROL BOARD - SAN DIEGO REGION
WATERSHED MANAGEMENT PROGRAM

FACILITY INSPECTION REPORT

Serenada
FACILITY OR DEVELOPER NAME (if different from owner)

**Ryland Homes of California, Inc. Serenada Development
Murrieta, Riverside County**

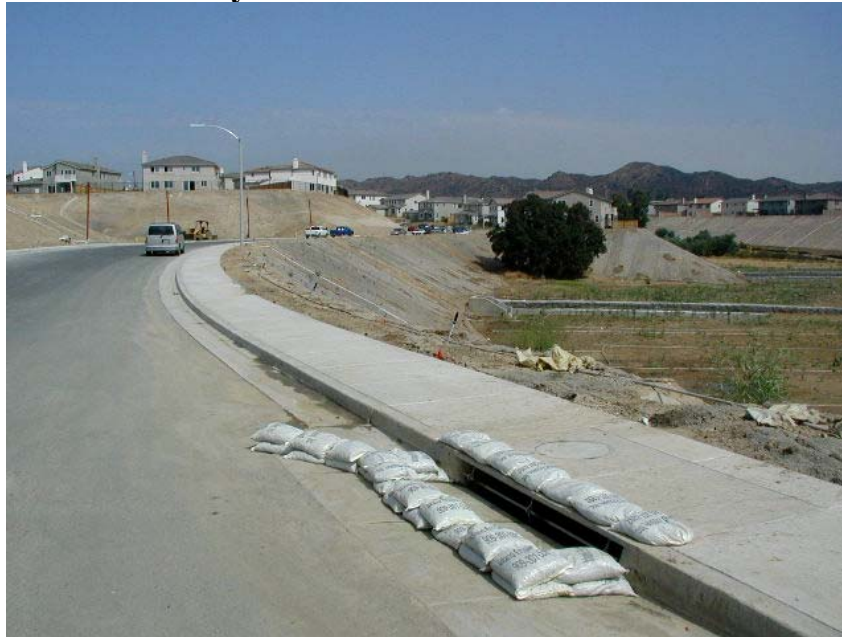
- Site implementing + maintaining BMPs per non rainy season requirements. Storm drain inlets are protected with gravel bags (Photo 1)
- Implementing street sweeping BMPs (Photo 2)
- Recently landscaped slopes along Jackson Avenue (Photo 3)
- Installed/replaced concrete washout area (Photo 4)
- Streets appeared to be well maintained with no large amounts of trash, debris or sediment.

Photo 1
Storm Drain Inlet BMPs In Place

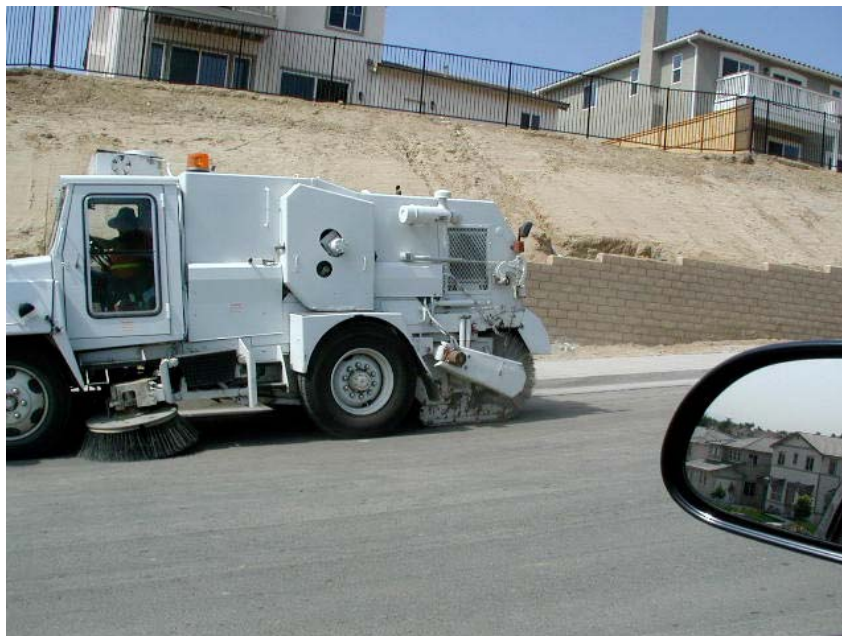
Photo 2
Street Sweeping In Progress

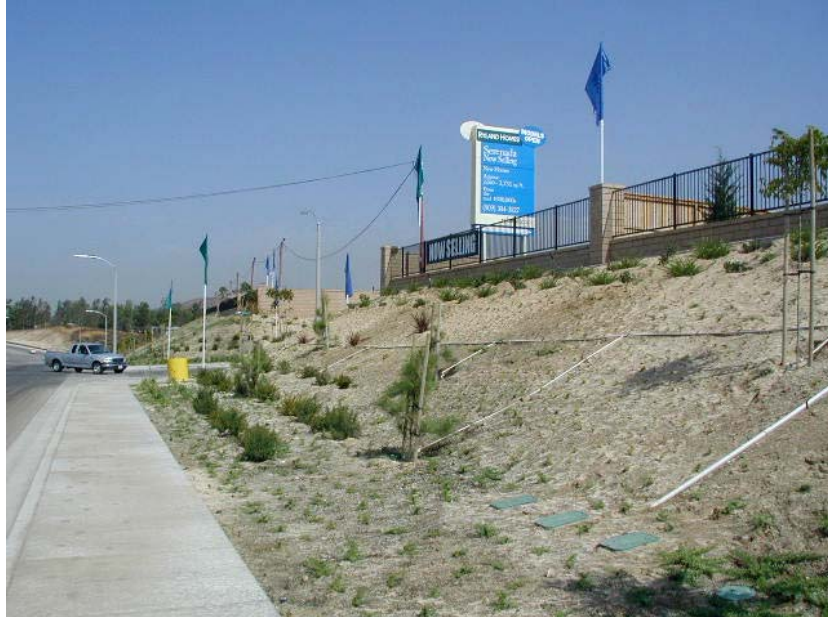
Photo 3
Landscaping on Jackson Avenue Slopes

- Will need to implement additional BMPs on site for upcoming rainy season.
- Needs to include new erosion control BMPs on slopes.
- Landscaped slopes not adequately grown in will need to be augmented with erosion control BMPs.

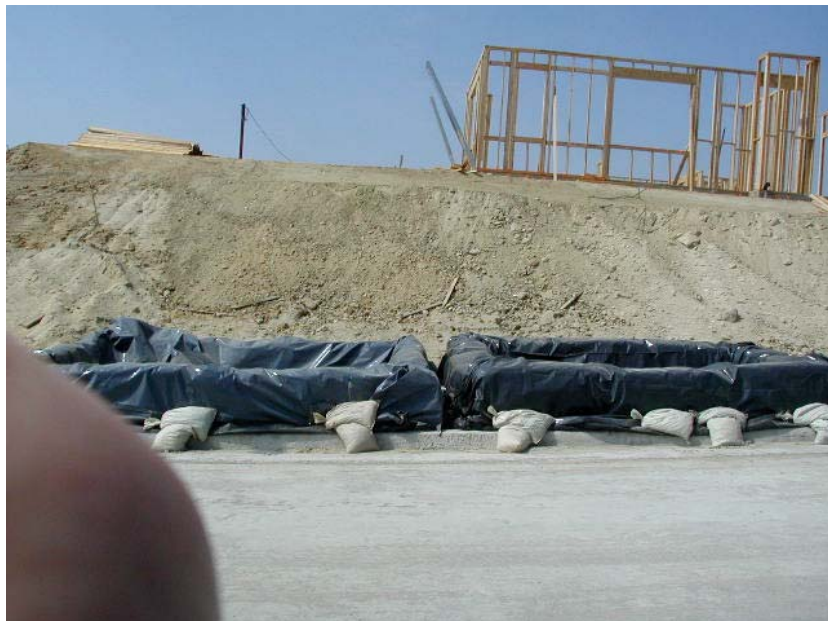
Photo 4
Designated Concrete Washout Area
